DAN NAPIER, CIH  
INDUSTRIAL HYGIENE

January 27, 2017

Meta Study for MRL and Bobcat Automated Stripe removal Equipment

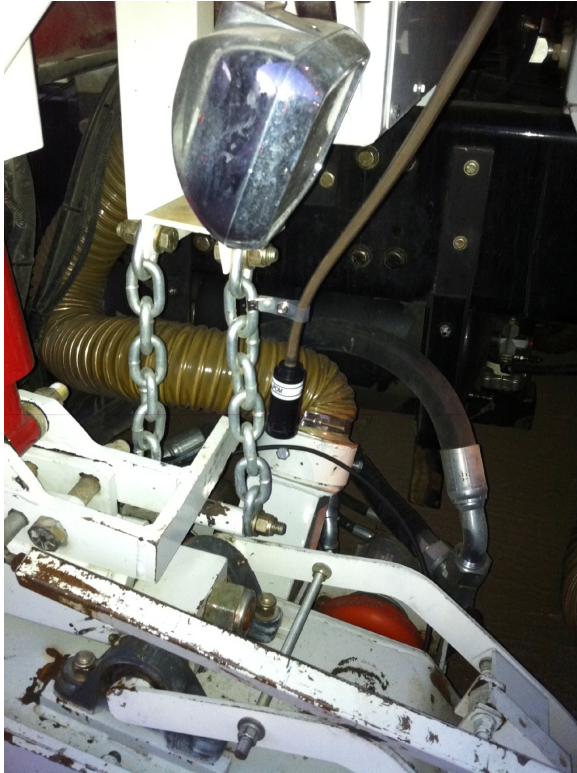
Area above the rotomill head. Note the dust free condition. This photograph was taken in the field during the work cycle.
