March 22, 2023

Meta Study for MRL and Bobcat Automated Stripe Removal Equipment

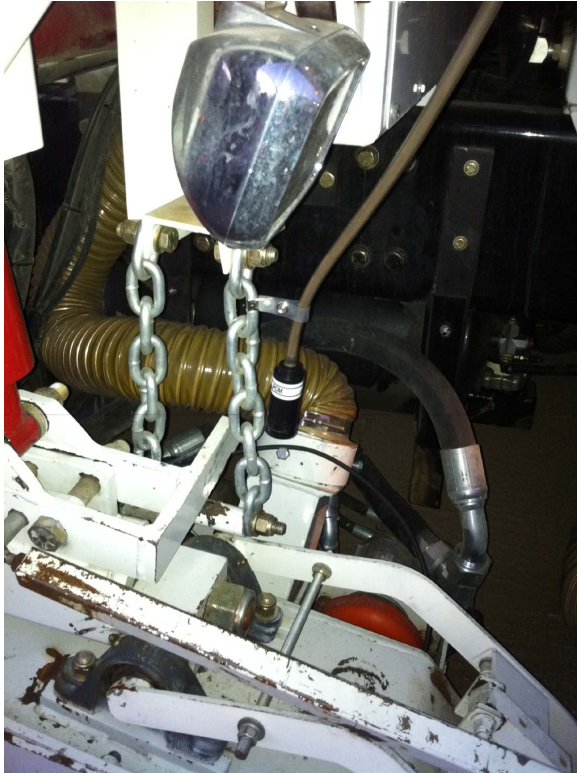
Area above the rotomill head. Note the dust free condition. This photograph was taken in the field during the work cycle.
